XAG P100/P100 Pro Motor & ESC Mandatory Maintenance Instructions

While the XAG P100/P100 Pro aircraft is operating, it would experience vibrations that might cause the screws securing the Motor connector and ESC to loosen, potentially causing a disconnection of power. The wear and tear of the isolators could have prompted the melting due to heat during the operation. Such an event could trigger an electrical surge and excessive heat production, possibly resulting in the Motor/ESC failure.

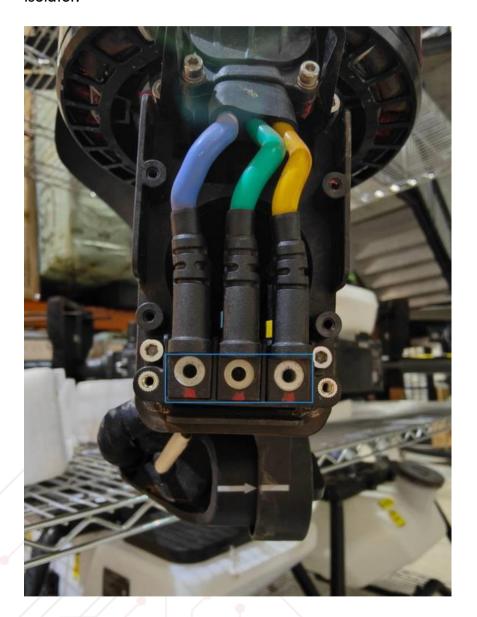
4. Should you find an isolator showing heat-related colour changes, replace it immediately. Also, ensure that each connector is paired with its appropriate isolator.

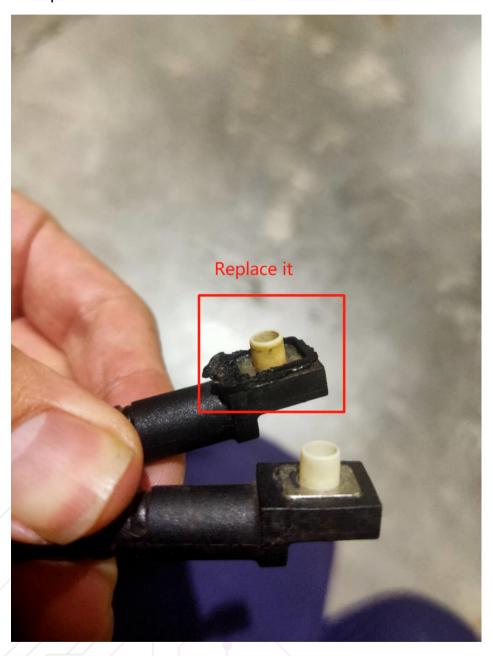
Example of heat-induced discolouration

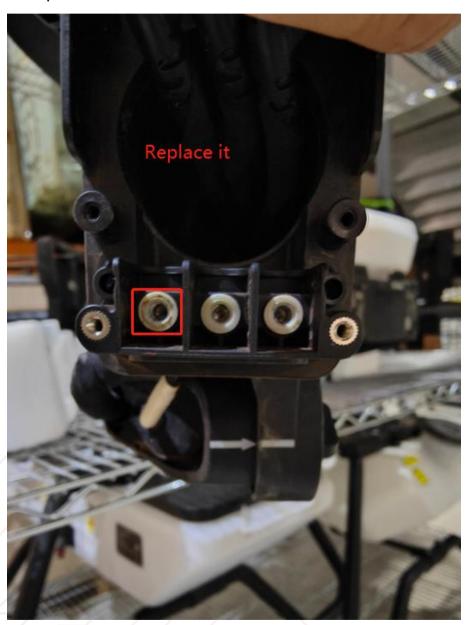
Example of heat-induced discolouration:

5. After the inspection and cleaning of the ESC isolators, substitute any that are worn or display signs of heat-related discolouration.
